# **Navajo Abandoned Uranium Mine**

## **Site Screen Report**

### **Mesa II, Mine No. 1, P-150 AUM Site**

**March 2010**

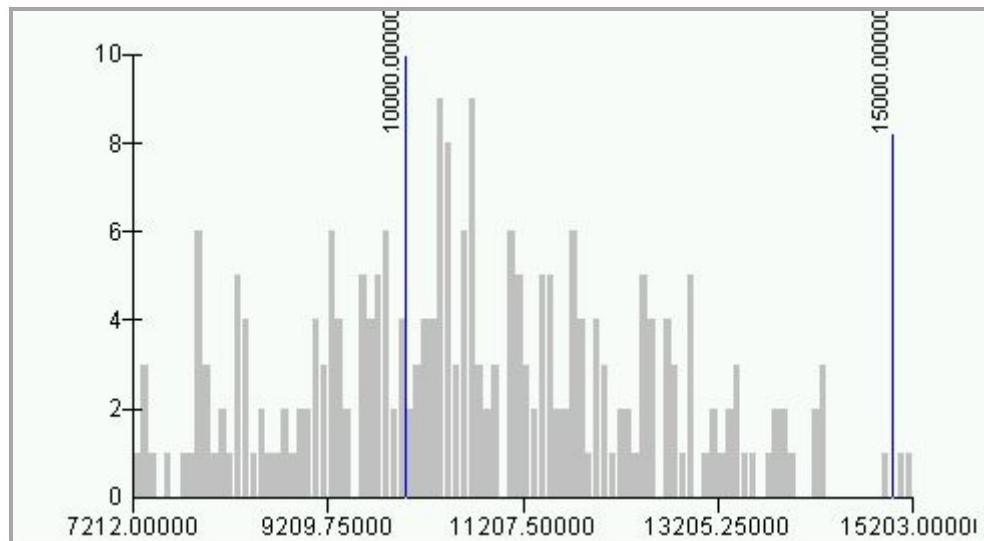
Weston was unable to access the site, due to steep grades. Measurements were collected in the vicinity of the, at approximately 75' north of the site boundary A total of 244 gamma radiation measurements were collected near mine site, ranging from 7,212 cpm to 15,203 cpm. . The measurements are represented in Figures 1 and 2.
